TECHNICAL MEMORANDUM 88/206

March 1988

RESPONSE OF SMA AND NARROW GAP  
HY80 WELDMENTS  
TO EXPLOSIVE SHOCK LOADING

J.F. Porter - D.O. Morehouse  
J.R. Matthews

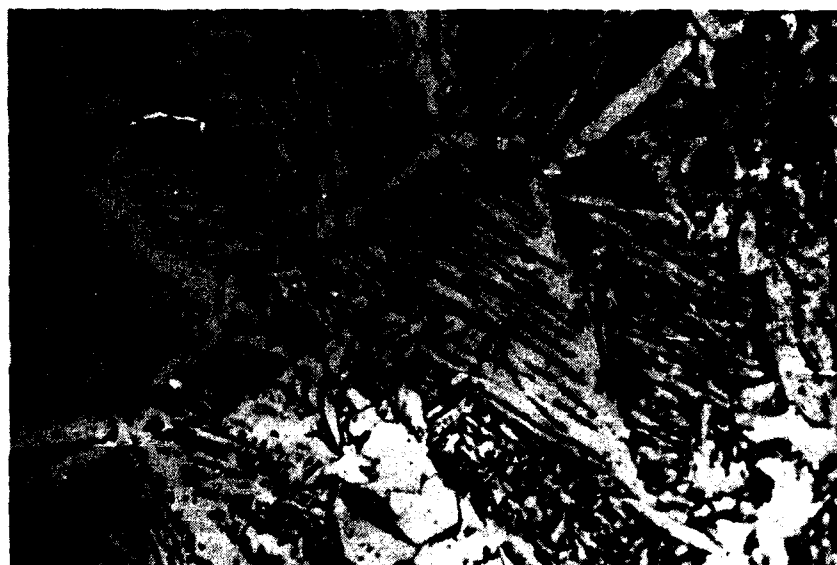
Figure 12: Microstructure of 70S1 Narrow Gap weld metal showing coarse acicular ferrite and side plate ferrite (500X)

As seen in Figure 12, the narrow gap 70S1 weldment revealed only about fifty percent coarse acicular ferrite with gross amounts of polygonal ferrite with sideplate ferrite growth. These microstructural components can adversely affect the weldment's toughness.
